# **Navajo Abandoned Uranium Mine**

## **Site Screen Report**

### **Cov087 Site**

#### **Navajo AUM Northern Region**

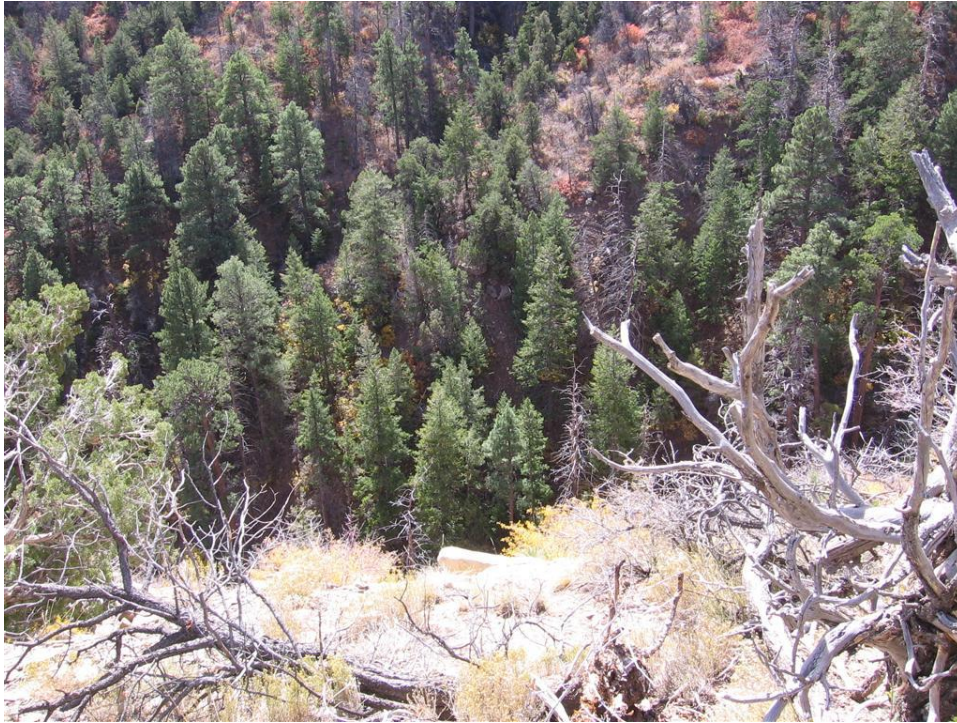
Photo 1. Mine site

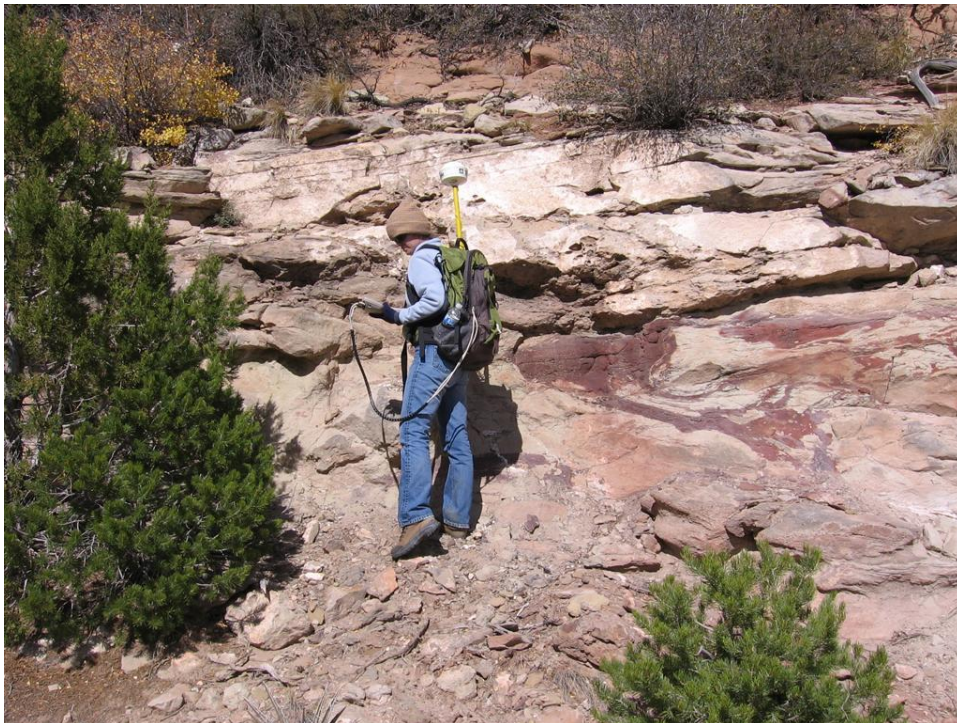
A total of 1,858 gamma radiation measurements were collected from the mine site, ranging from 9,091 cpm to 285,399 cpm. Measurements of the dust-exposed uranium rocks were found at levels over 200,000 cpm, and approximately 50,000 - 60,000 cpm at edge of cliff. The measurements are represented in Figures 1 and 2.

Photo 2. Exposed uranium dust

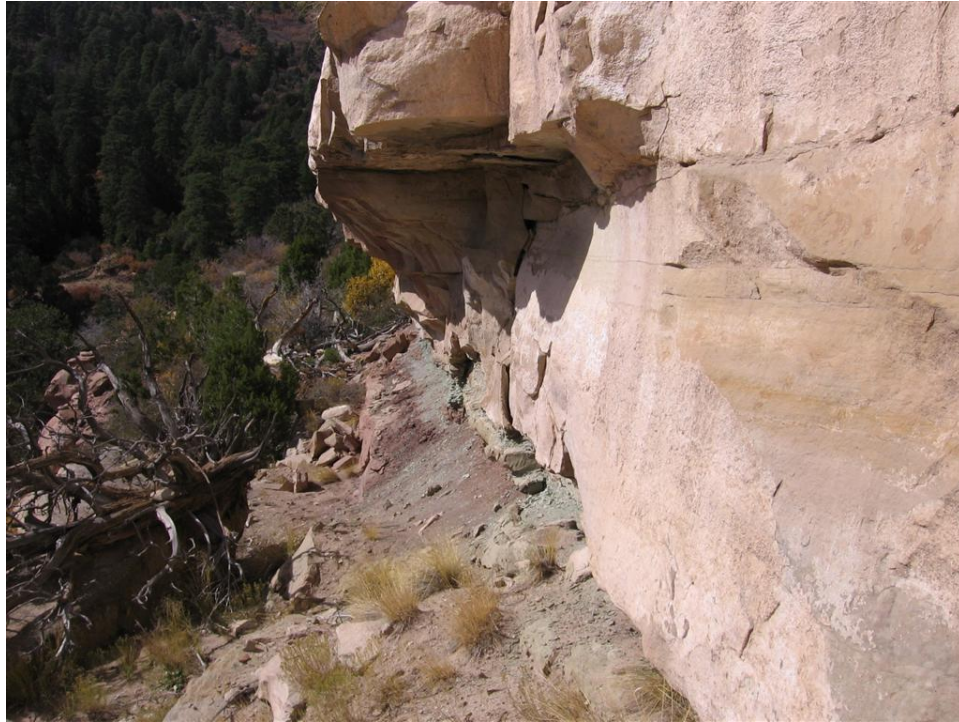
Photo 3. Cliff earea

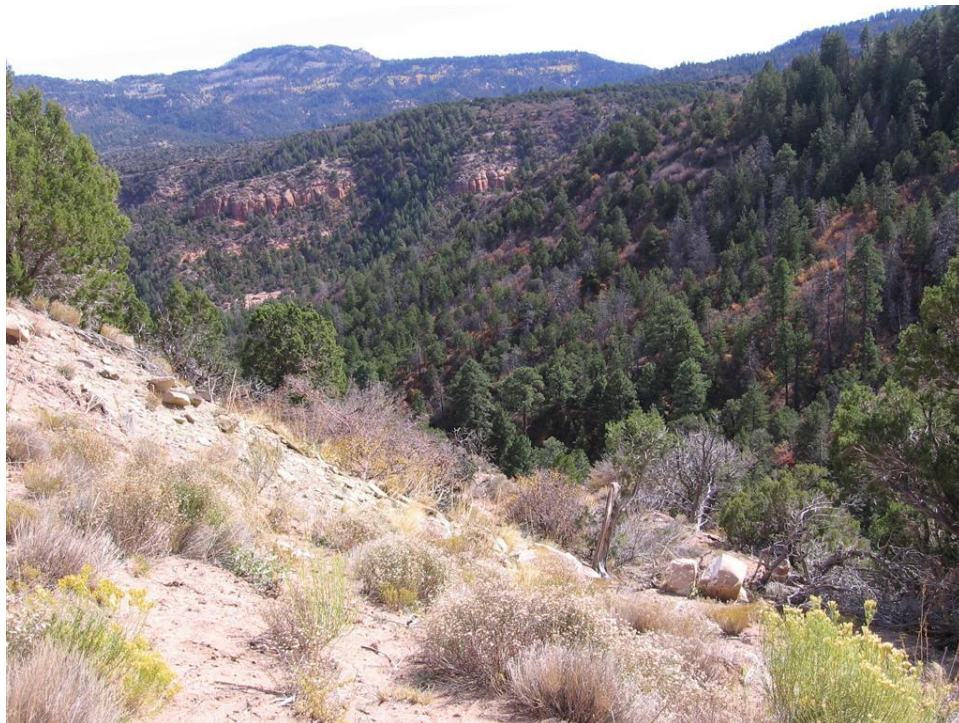
Photo 4. Down slope edge
